Guildford Streetscape

Swan Lane Analysis

May 2019

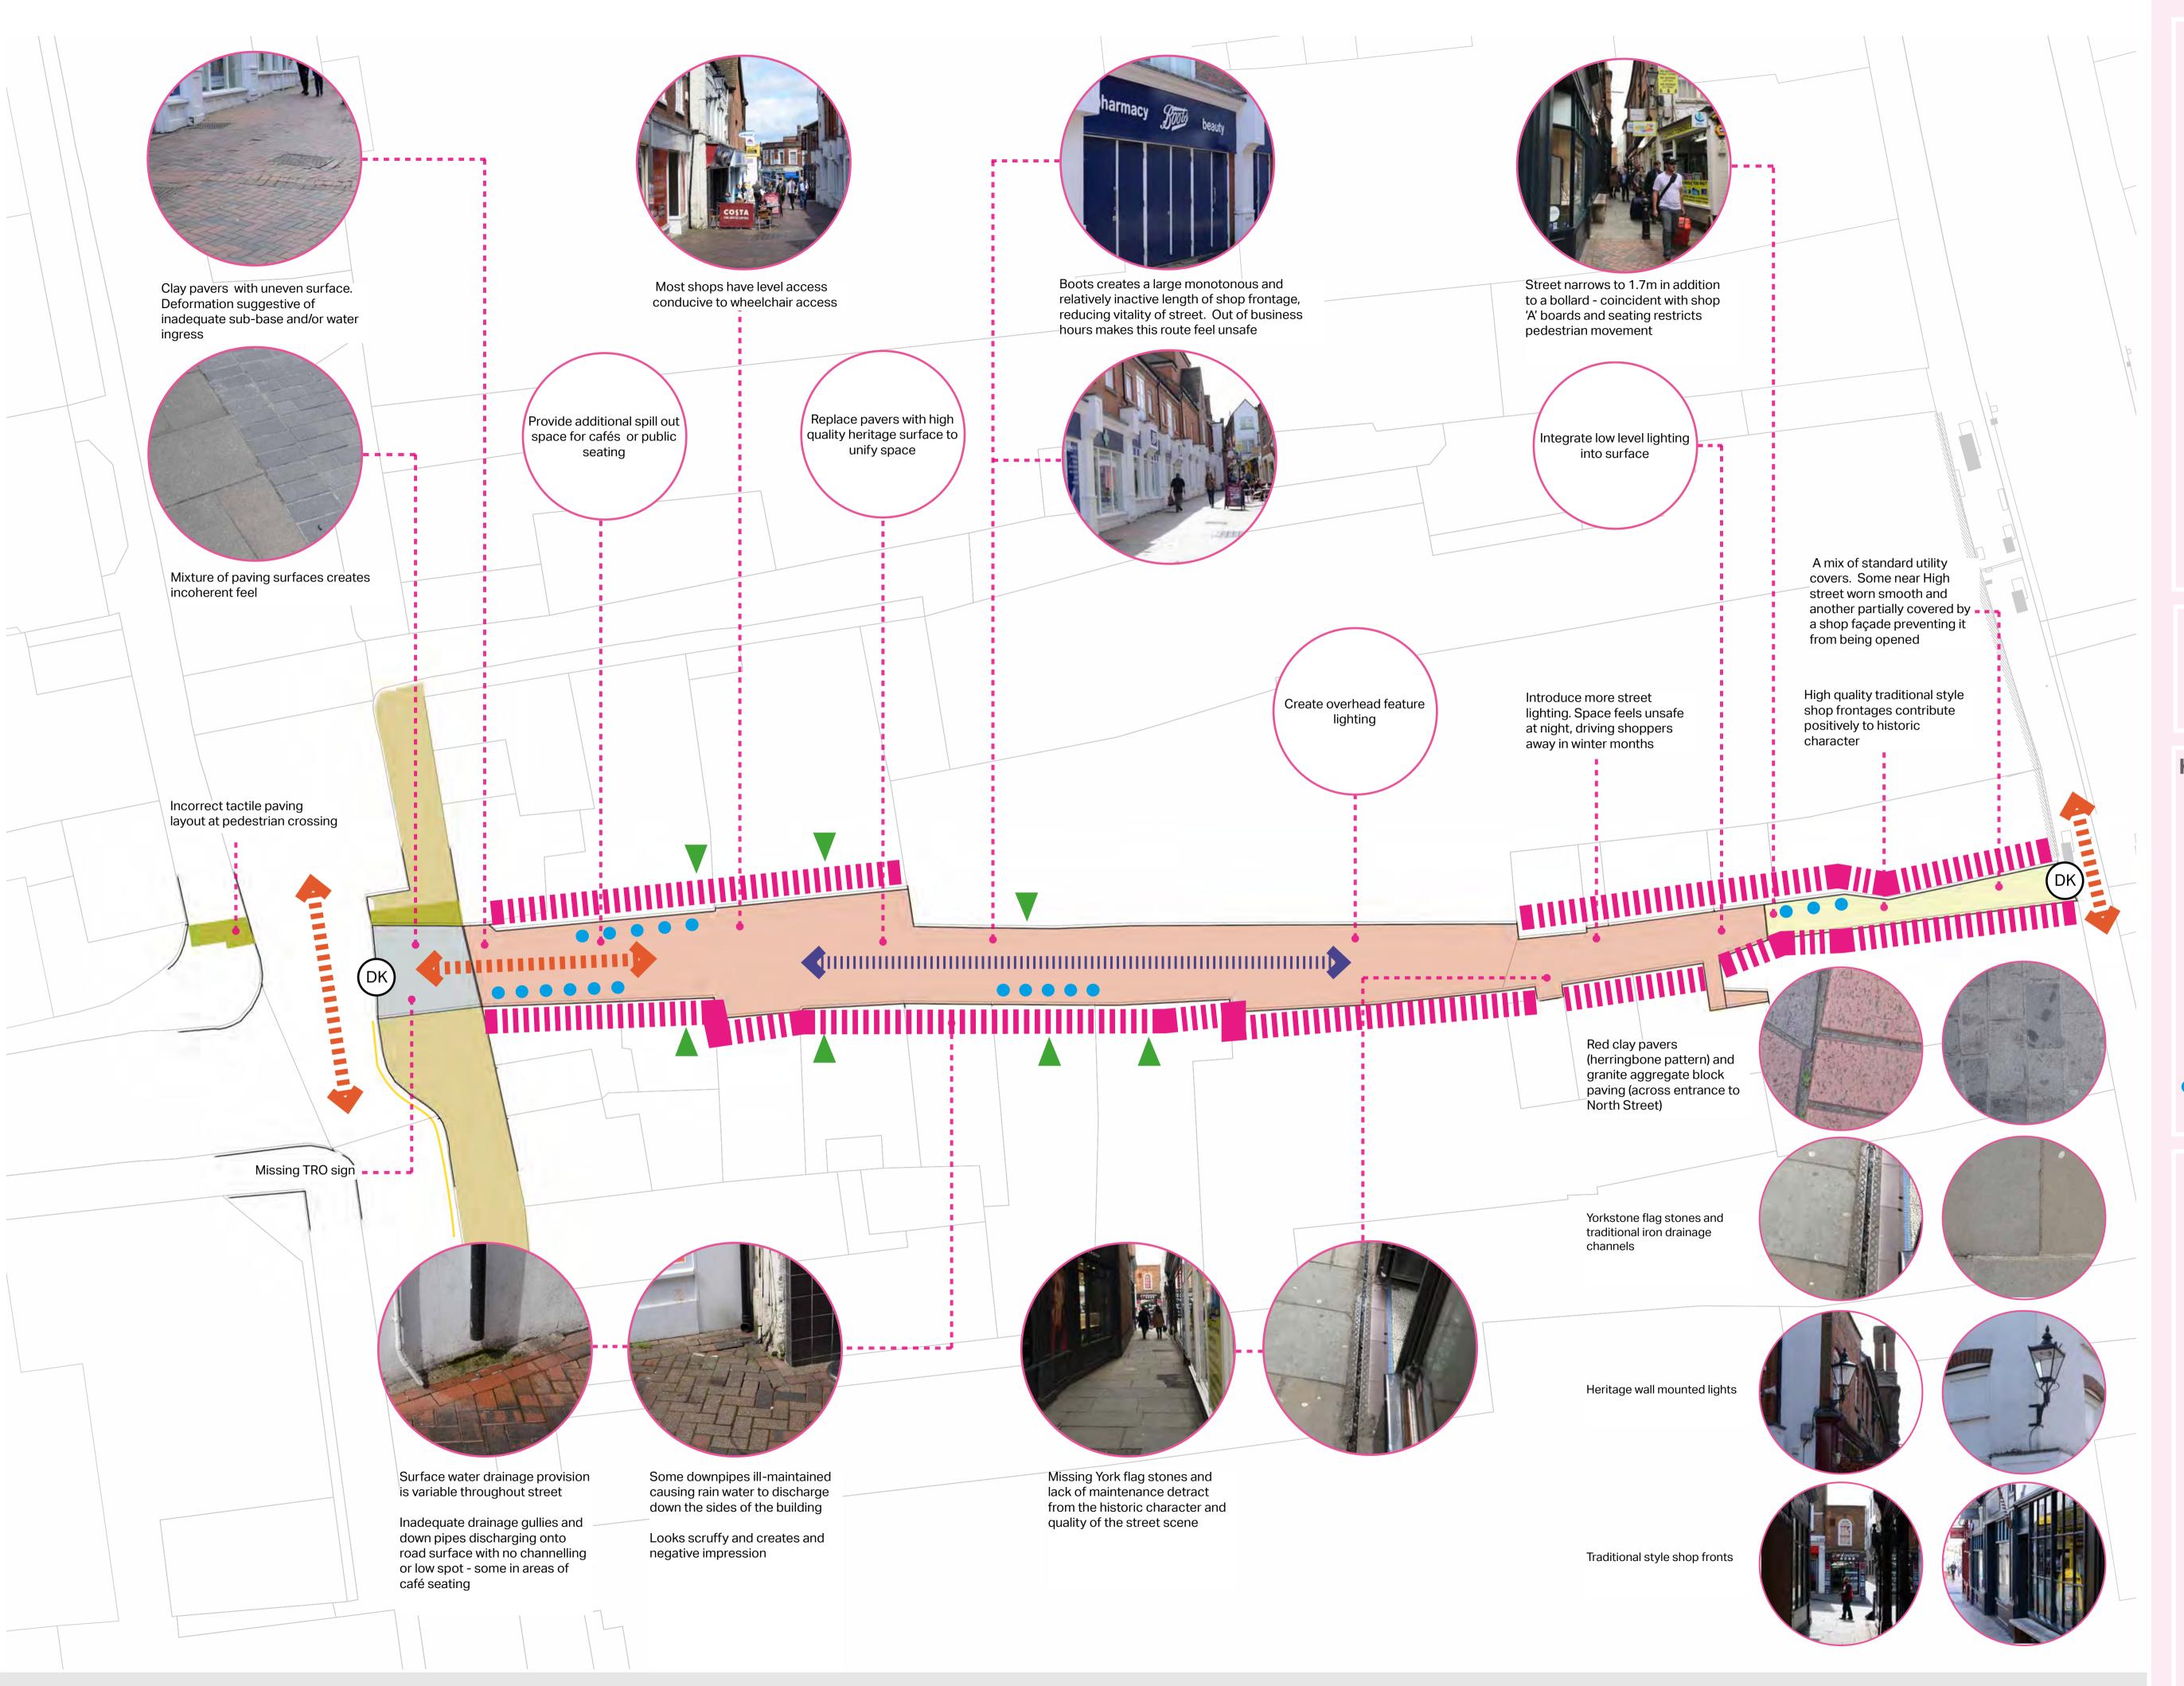
- High pedestrian flows during retail opening
- Unique space part of
- historic street pattern
- Good open façades and • retail access

- Difficulty servicing retail •
- Appearance of paving •
- Poor lighting •
- Streetscape bland

- Promote heritage •
- Improve retail sense of place •
- Safety improvements night • lighting
- Branding street & wayfinding •

- Weak retail market •
- •
- Complex steps and access
- requirements
- Drainage

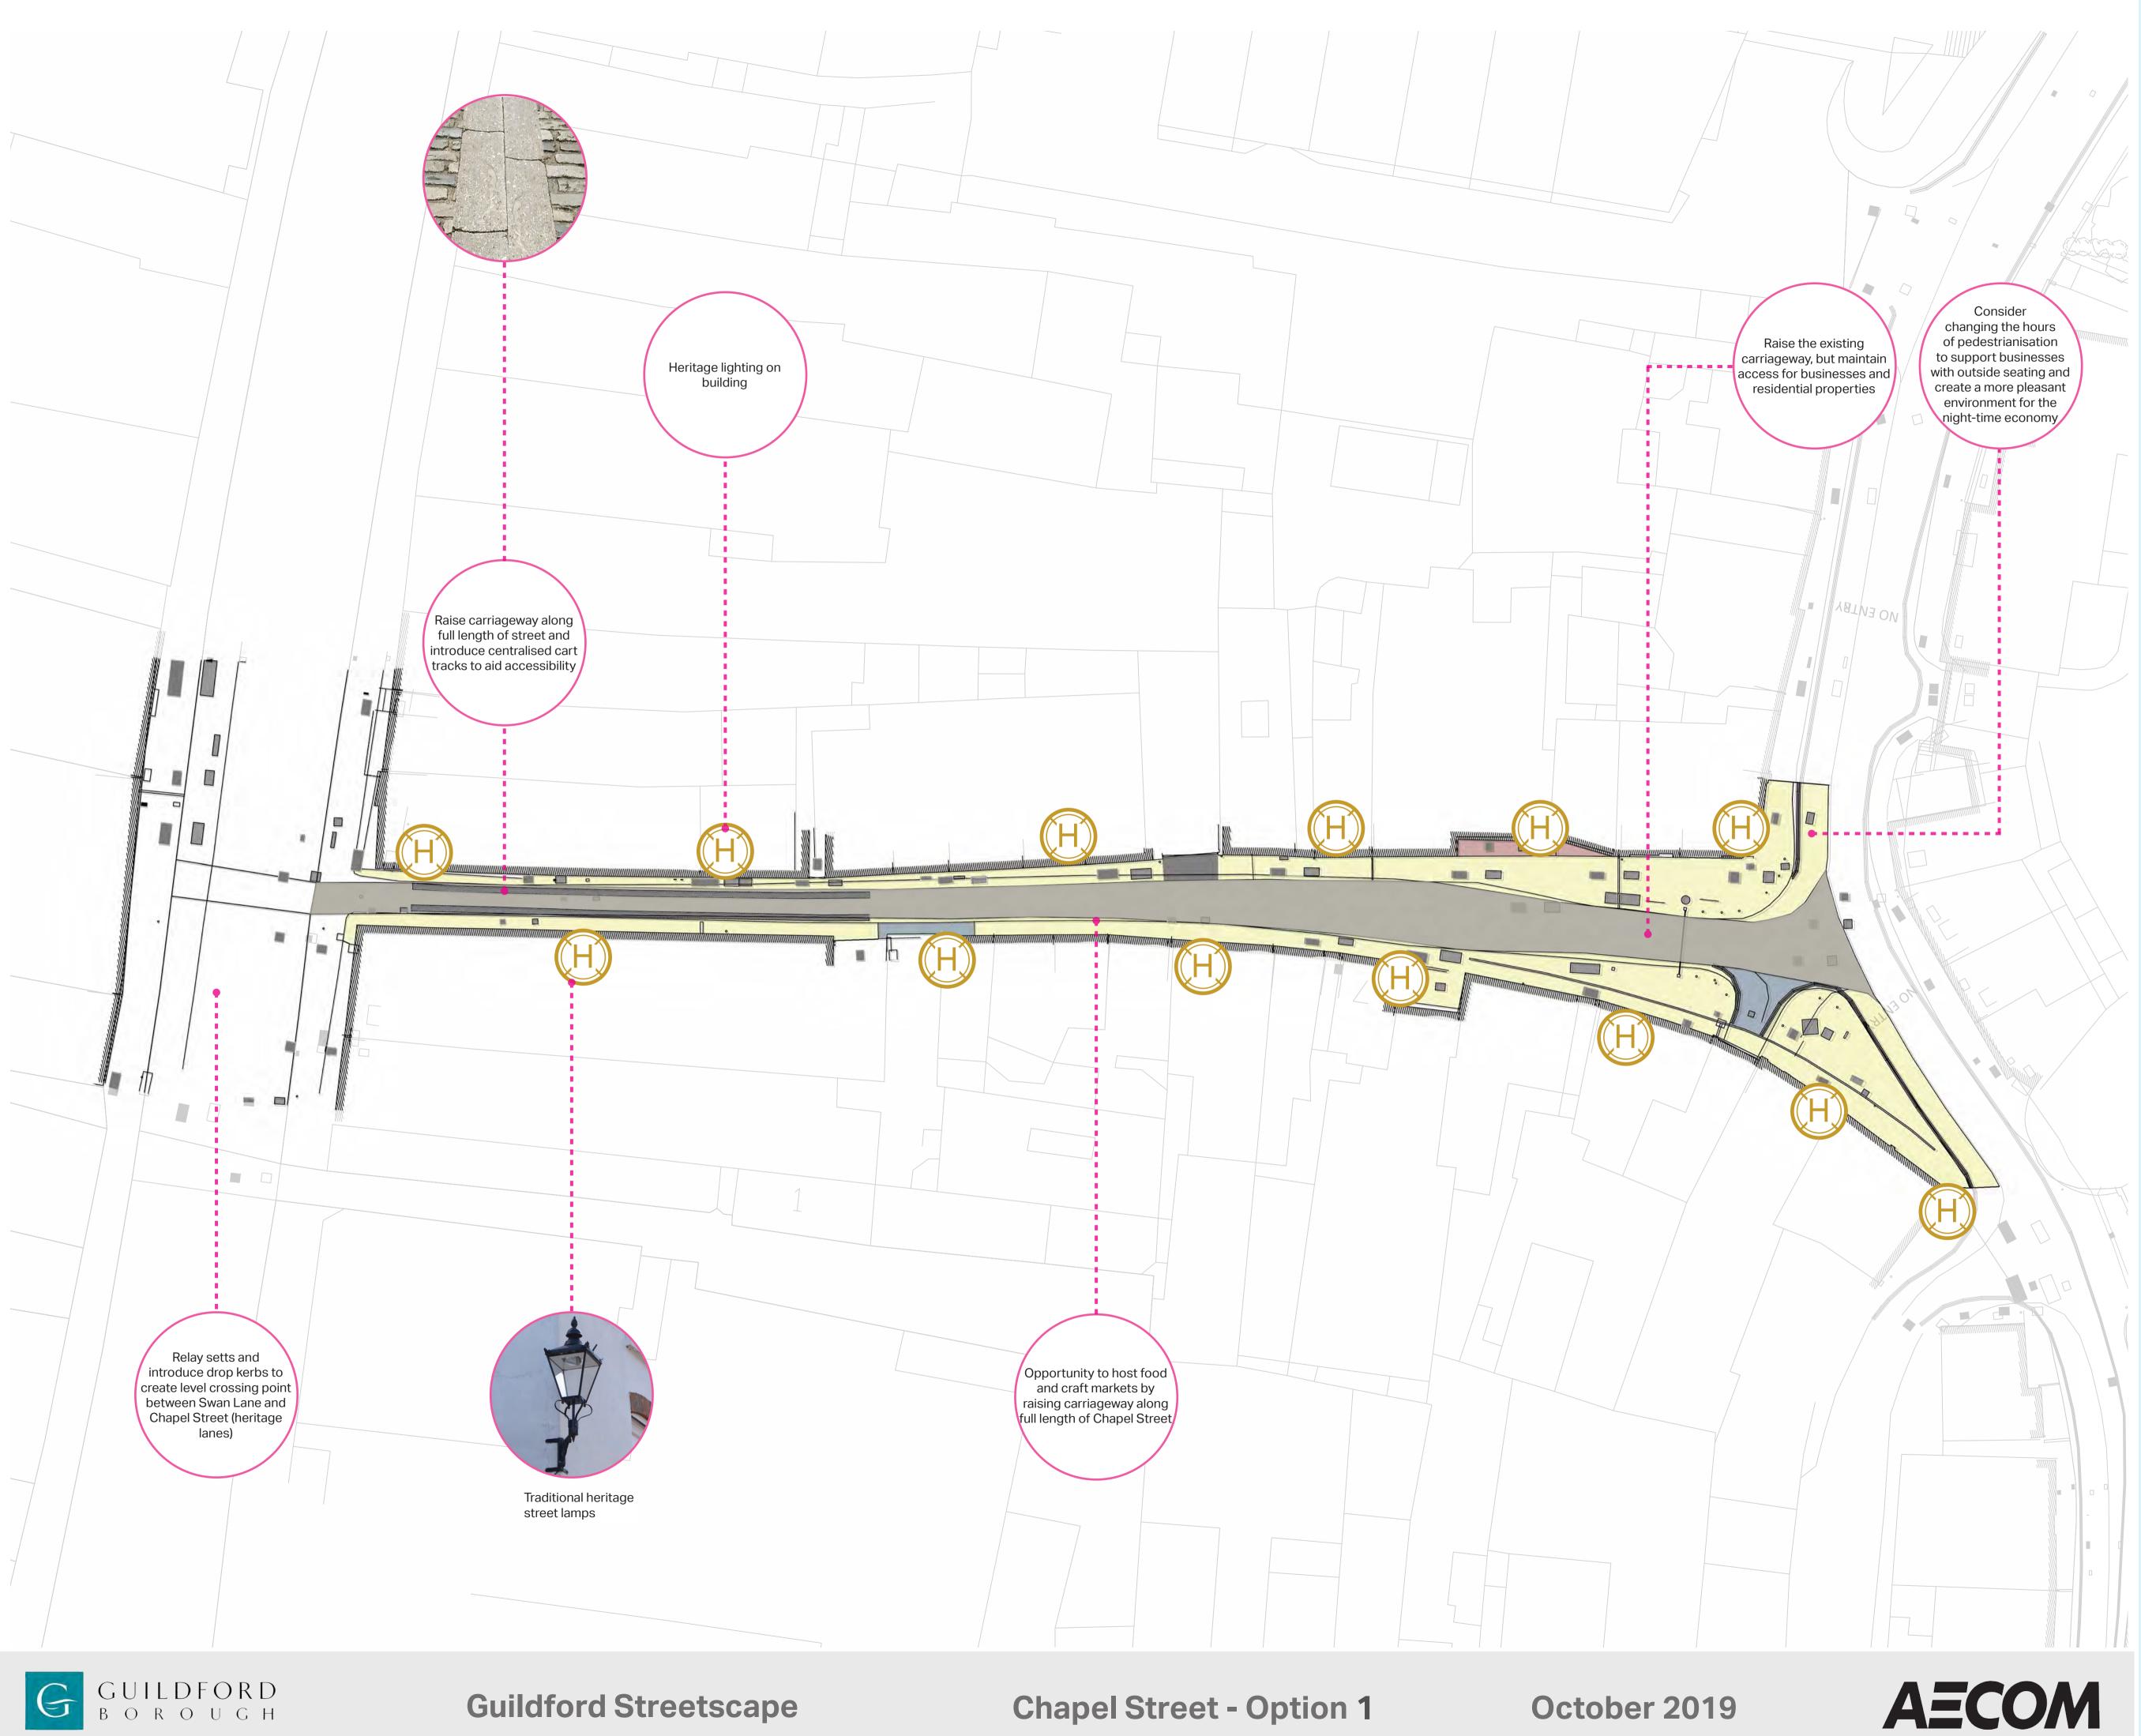
Chapel Street - Option 1

LANDSCAPE FEATURES Yorkstone (random pattern) Asphalt Cobbles (reuse existing) Staffordshire Blue Pavers Brick Paving Manhole 3210 5 10m KEY $\mathbf{\hat{F}}$ Heritage Lighting

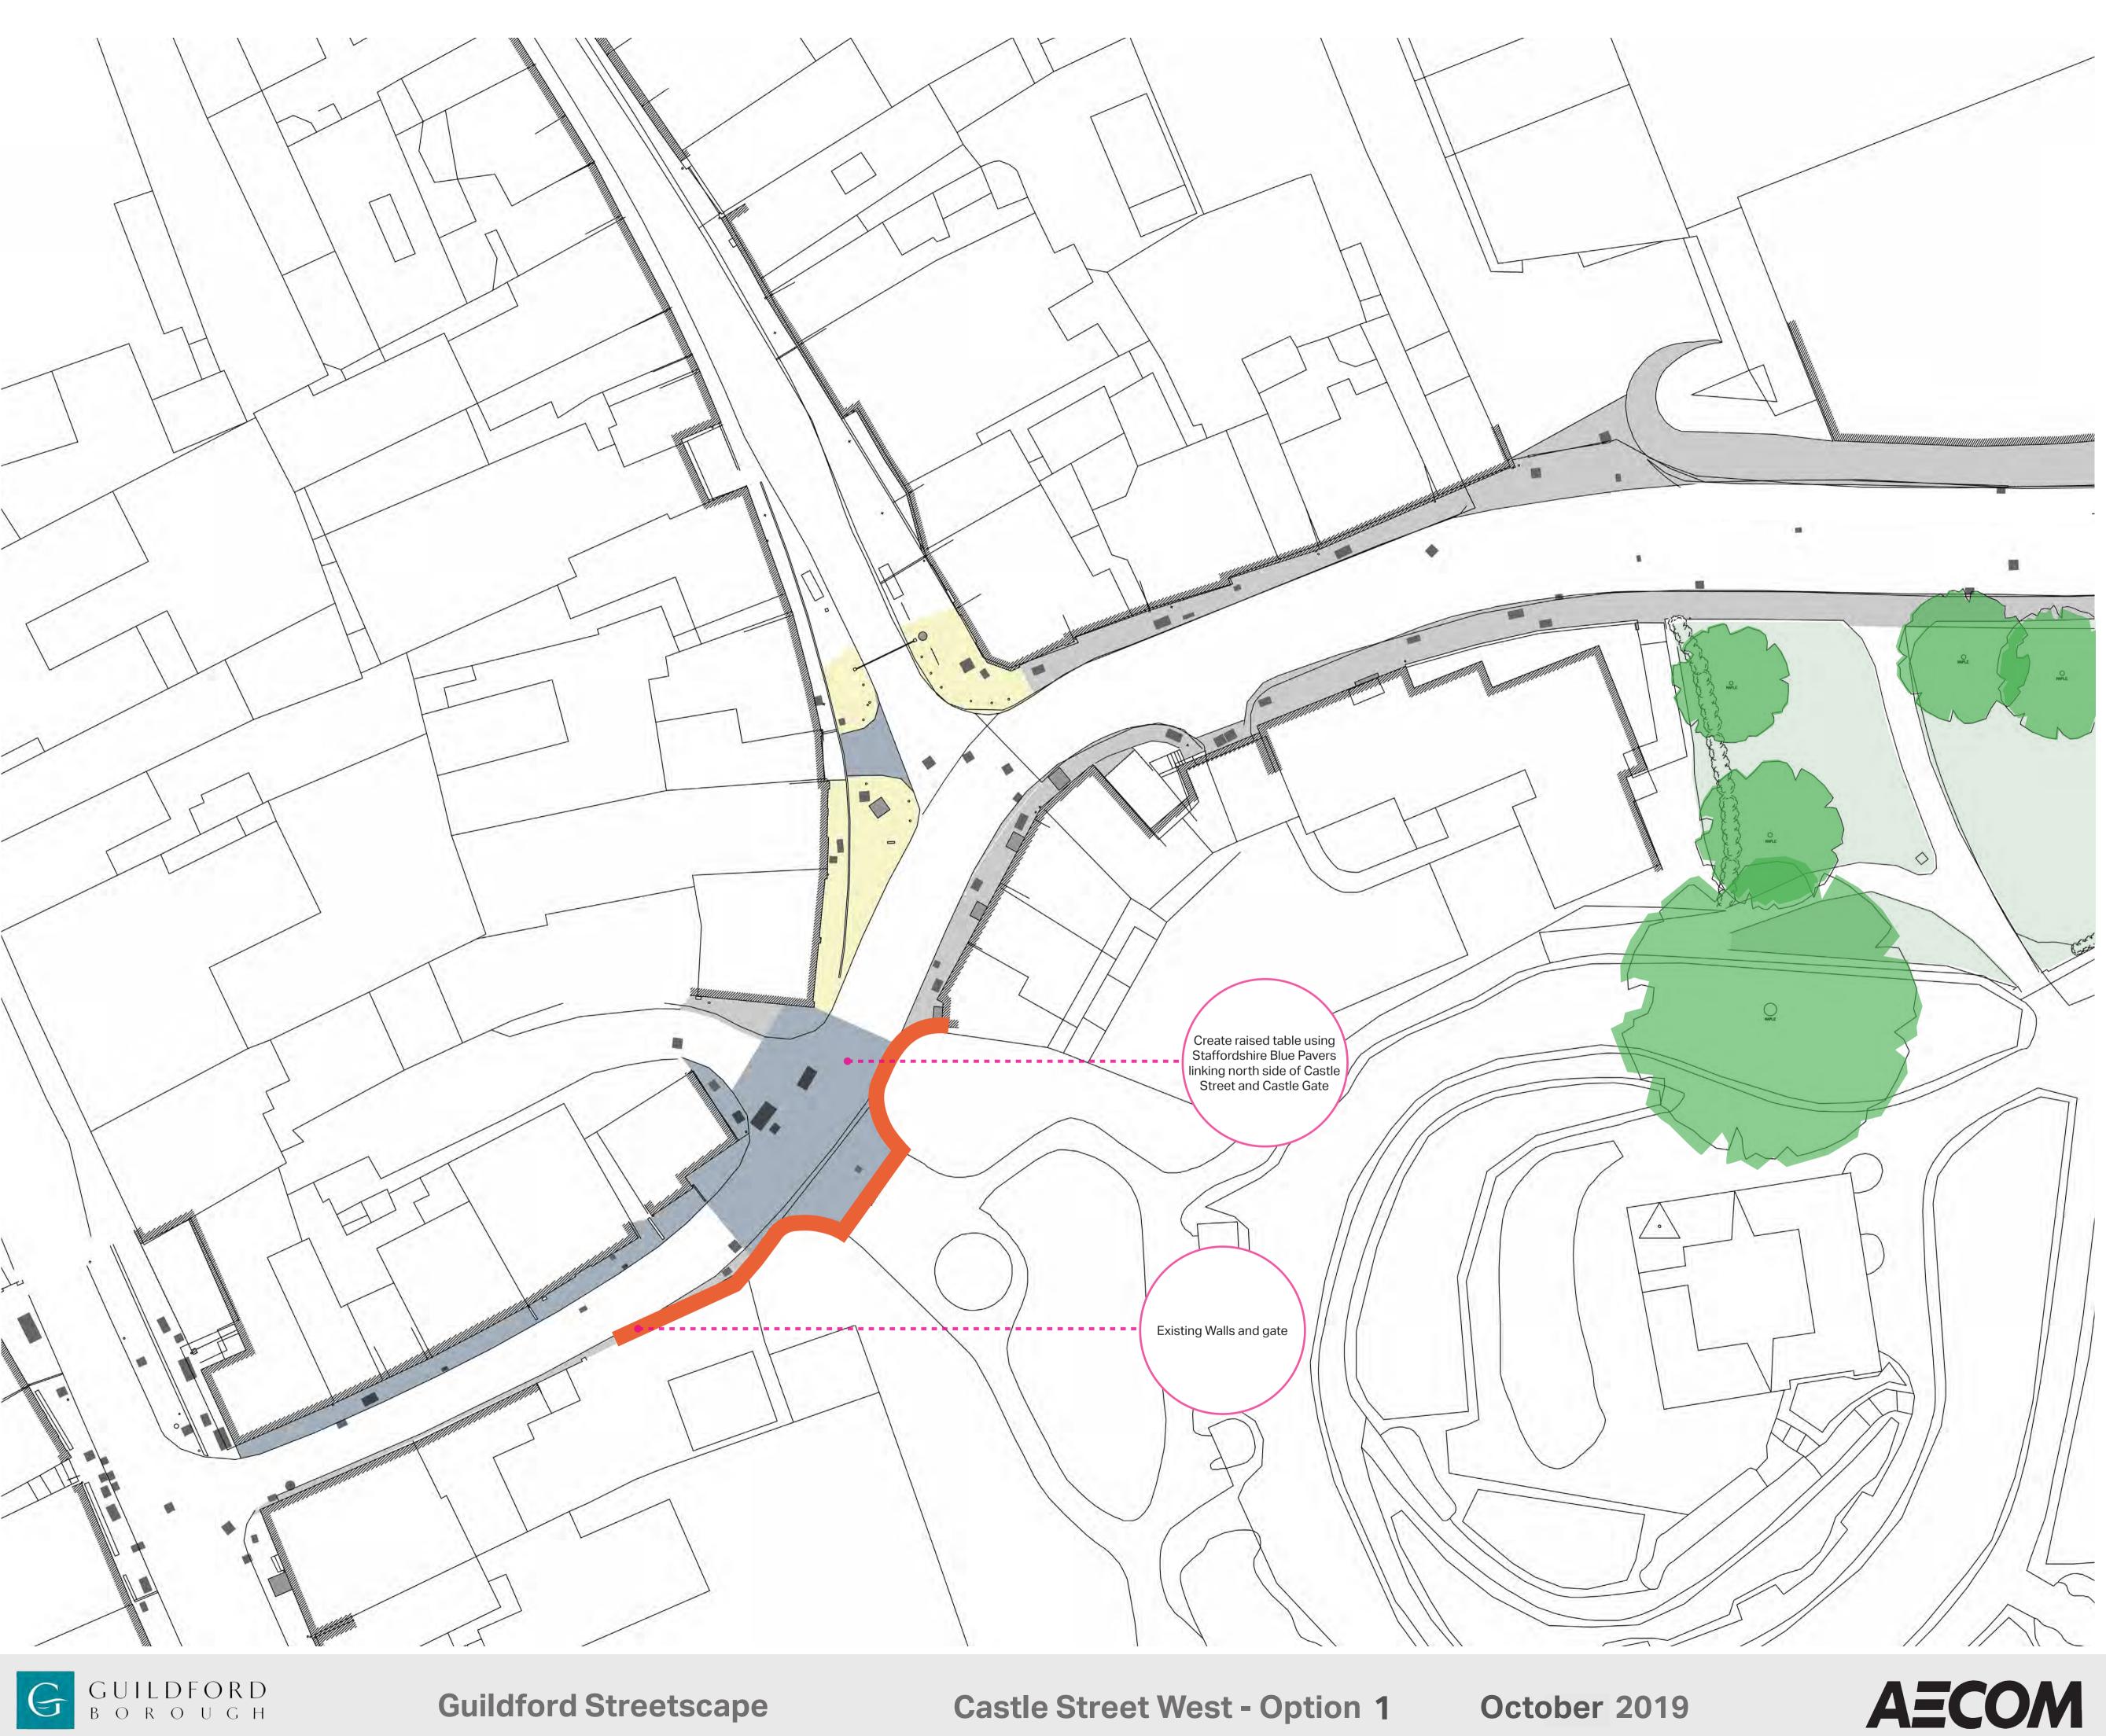
Castle Street West - Option 1

LANDSCAPE FEATURES Yorkstone (random pattern) Asphalt Staffordshire Blue Pavers Existing Trees Manhole
